SchwankAir Case Study

SchwankAir eliminates frost with a vertically mounted 4000 Series Air Curtain

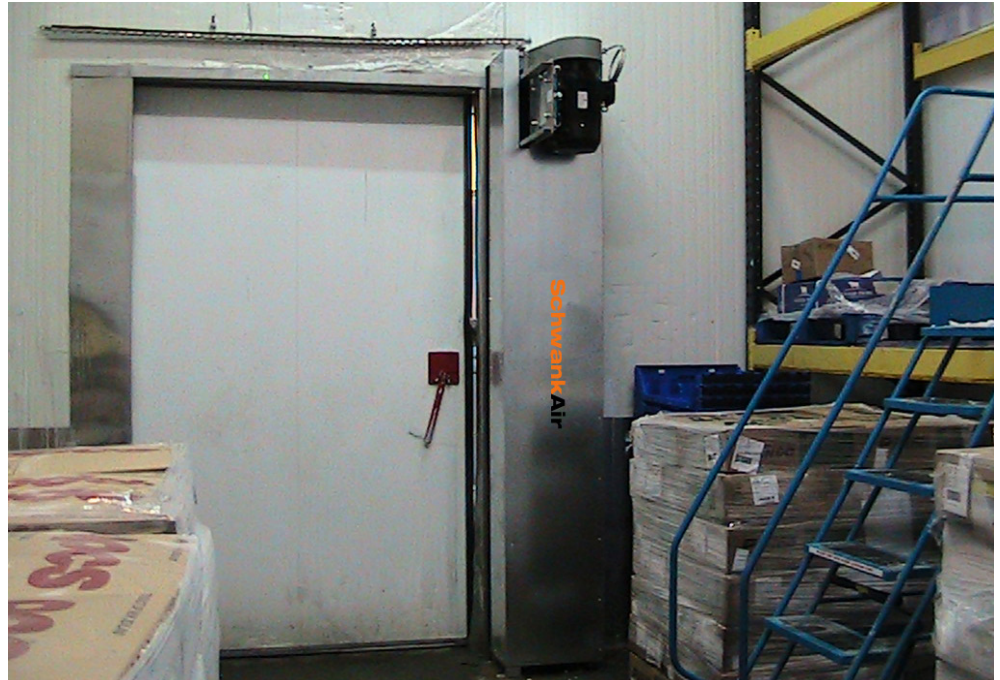
Installation of a vertically mounted SchwankAir 4000 Series Air Curtain created a smooth laminar air flow across the opening and formed a 90% seal.

The SchwankAir Curtain recirculated the freezer room air. In doing so it effectively de-stratified the room air and equalized the room temperature. As a result, the storage capacity in the freezer increased as the highest shelves of the storage racking could now be used.
